D'APPOLONIA CONSULTING ENGINEERS INC PITTSBURGH PA
NATIONAL DAM INSPECTION PROGRAM. PA-647 DAM (NDI ID NUMBER PA-8--ETC(U)
MAR 79

PHASE I REPORT
NATIONAL DAM INSPECTION PROGRAM

PA-647 DAM
NDI I.D. NO. PA-821
DECEMBER 8, 1978

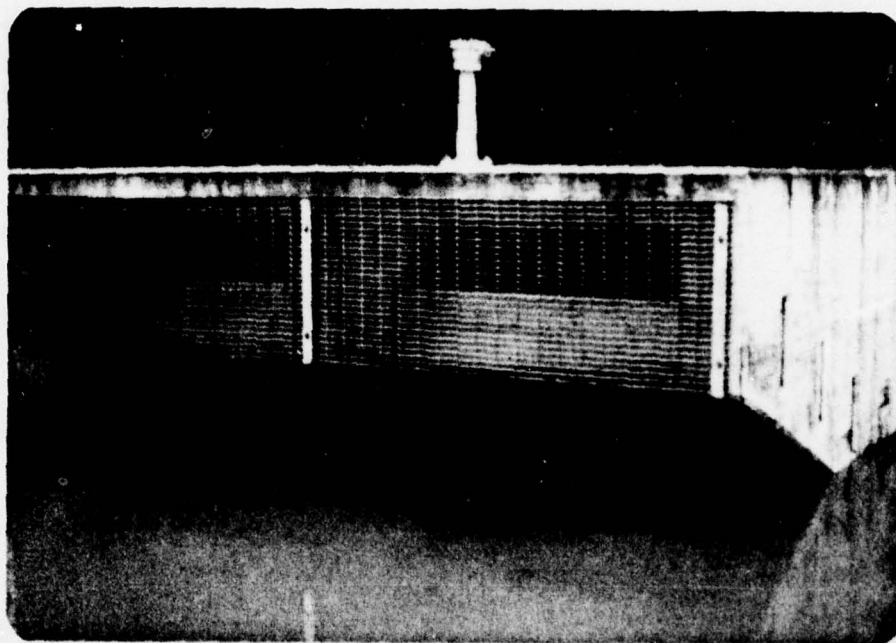
Photograph No. 3
Primary spillway, drop inlet structure.
